Revitalizing the Space Shuttle's Thermal Protection System with Reverse Engineering and 3D Vision Technology

By Brad Wilson and Yishai Galatzer

| REPORT DOCUMENTATION PAGE | | | | Form Approved OMB No. 0704-0188 | |
|--|---|---|---|--|---|
| 1. REPORT DATE (DD-MM-YYYY) 21-07-2008 | | 2. REPORT TYPE Technical | | 3. DATES COVERED (From - To) June-2003- Oct-2005 | |

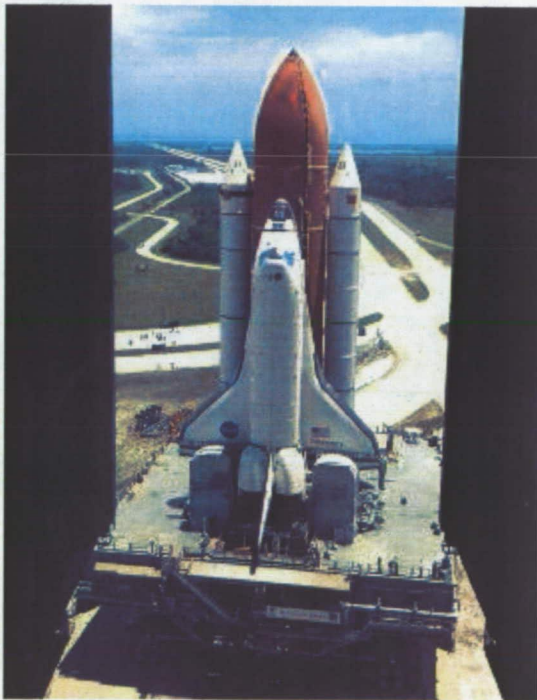
Figure 1 – The space shuttle being transferred to launch site

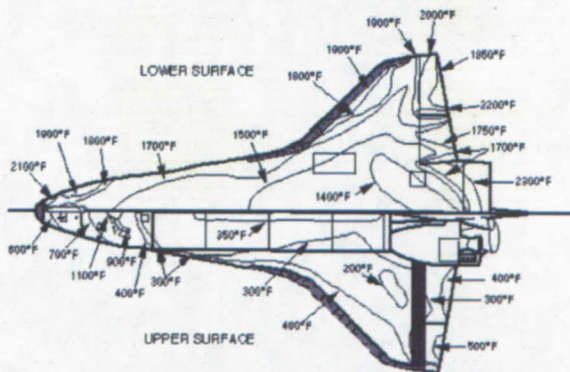
Figure 2 – Upper and lower surface temperatures

The procedure used to manufacture a thermal protection tile is elaborate and complex. But the end result is a tile with the precise combination of accurate fit, low weight, high strength, and the required thermal properties. The tiles are positioned literally all over the Shuttle, particularly on the lower surface enduring high air flow during the reentry process where extreme temperatures can melt the aluminum structure *See Figure 2.*

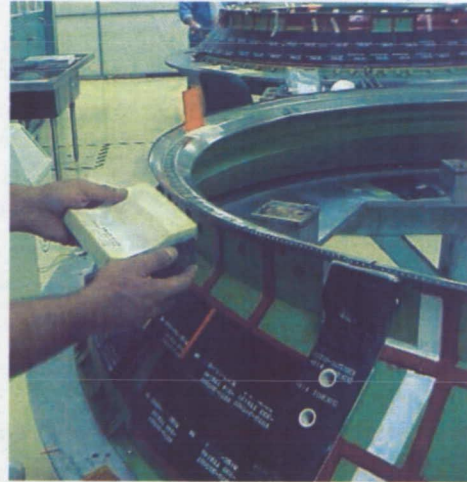
Figure 3 – Hand made tile pattern

One way to approach the problem was to make a pattern by hand to replicate the open tile cavity, and then copy the pattern into a silica-based tile using a gunstock machine. This method was inaccurate and at times required iterations to get close to the desired shape. *See Figures 3 and 4.*

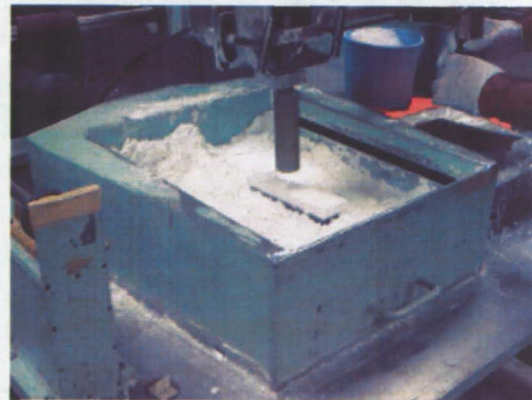
Figure 4 – Tile being cut on a gunstock machine

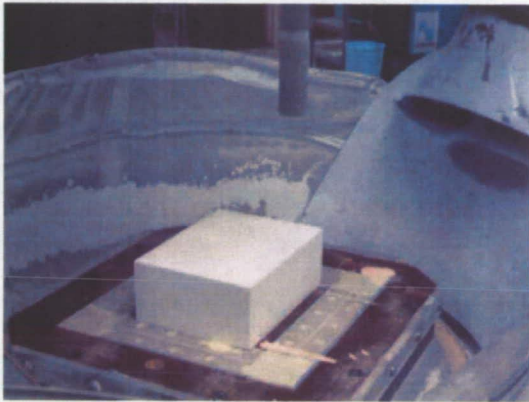
Figure 5 - Tile being cut on a 5 axis milling machine

Hence, the replacement tile could not be produced directly from the original model. Instead the tile would be initially cut using a 5-axis milling machine, then trial fitted to the cavity. Once again, this procedure suffered from human errors, and several iterations were required to get the desired result. *See Figure 5.*

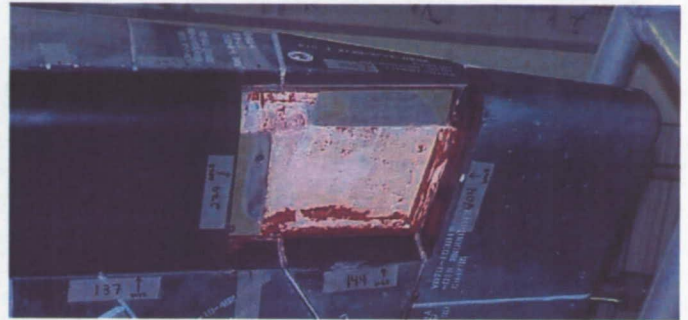
Figure 6 – Single tile cavity

First, the cavity that required measurement had a variety of color and reflectivity/shininess properties. The cavity could not be white sprayed, as the Shuttle is a space ready vehicle. The cavity created by the aluminum substrate, isolation materials, and neighboring tiles. These conditions pose problems for certain types of metrology devices. *See Figure 6.*

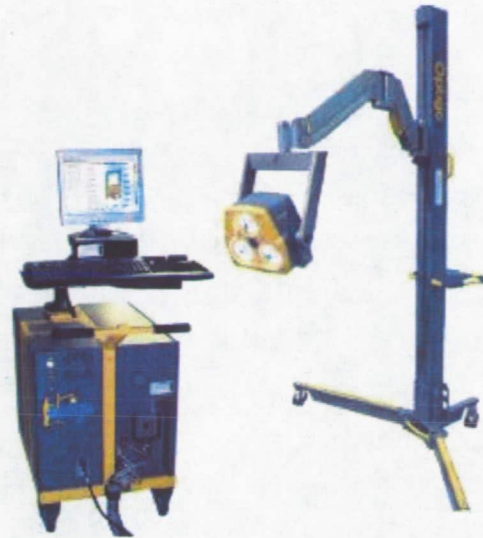
Figure 7 – Optigo 200 system

The TPS team asked for a demonstration at the Orbiter Processing Facility (OPF). CogniTens, Inc. presented the Optigo 200 system (see Figure 7) at the Kennedy Space Center. During the evaluation period, tile cavities were scanned directly on the shuttle. The scanning was performed while other technicians continued to work all over the shuttle. The point cloud was then processed into an STL file using the wrap functionality of Geomagic Studio, software from Geomagic, Inc.

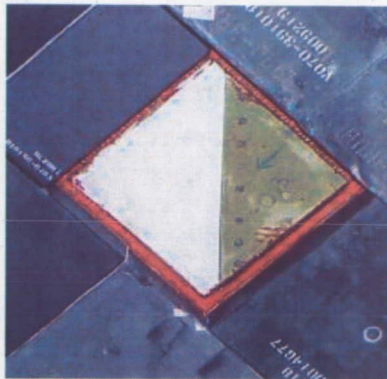
Figure 8 – tile cavity

The new procedure involved scanning the cavity, converting the point cloud into an STL file, and importing the data into a CATIA CAD system. The CAD operator then created offset surfaces from the adjacent tile walls to generate a new CAD design for the tile. This CAD model served as the new master file, and the data source for the CNC program.

dramatic improvement as compared to the normal benchmark of up to one week per tile. *See Figures 8 through 11.*

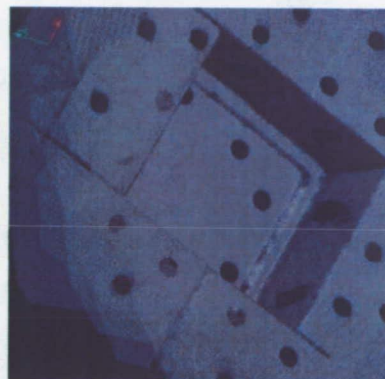
Figure 9 – point cloud

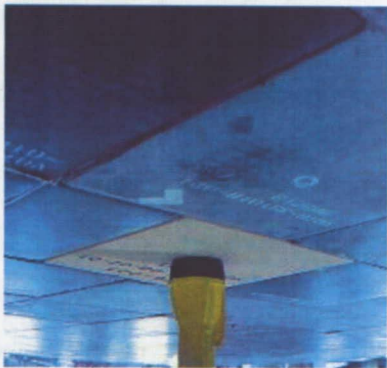
Figure 10 – test pattern in place

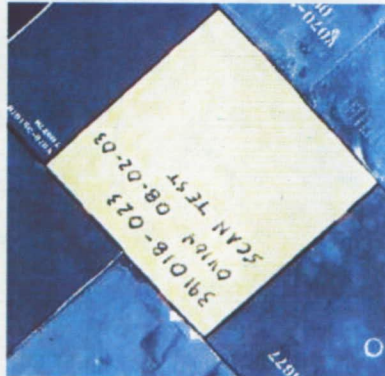
Figure 11 – test pattern fully assembled

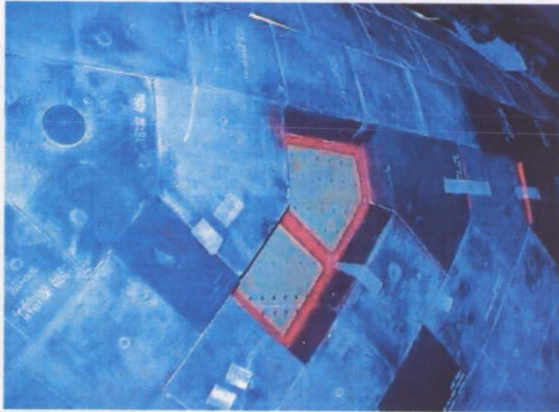
Figure 12 – Cavity left by removing two adjacent tiles

The routine was then standardized, and today is an approved method for tile replacement. The process was later expanded to produce several tiles at the same time, in situations where multiple tiles had to be removed in a specific area. *See Figure 12.*

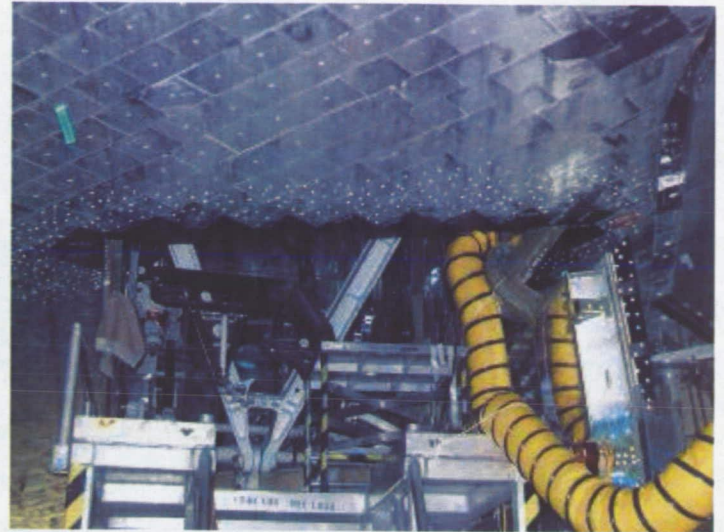
Figure 13 – Landing gear door in open position

The TPS team scanned the doors in open and closed positions (*see Figure 14*). They removed the tiles to be replaced, and scanned the resultant cavities. Using digital assembly tools in the CogniTens software, all the measurements were assembled into one point cloud. The team proceeded to design new tiles to fit into the open cavities. The end result was successful and introduced notable timesavings to the overall OPF activity. *See Figure 14.*

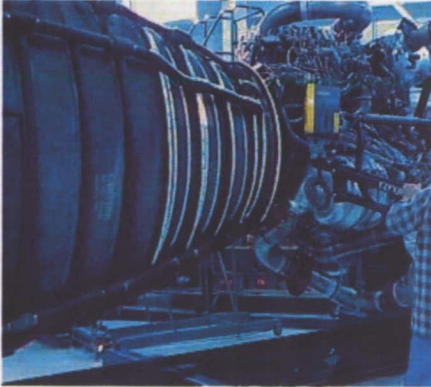
Figure 15 - Main engine nozzle being scanned

Scanning technology has also proved effective for developing protective covers for critical components. The main engine nozzles of the Shuttle were scanned. Utilizing the point cloud data, molds were created to produce protective covers that shield the nozzles from launch site related debris. See *Figures 15 through 18.*

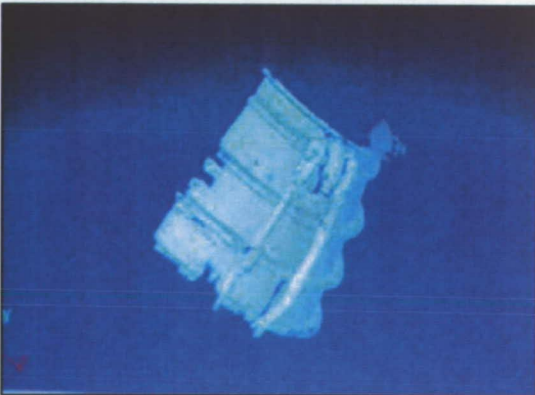
Figure 16 - Point cloud

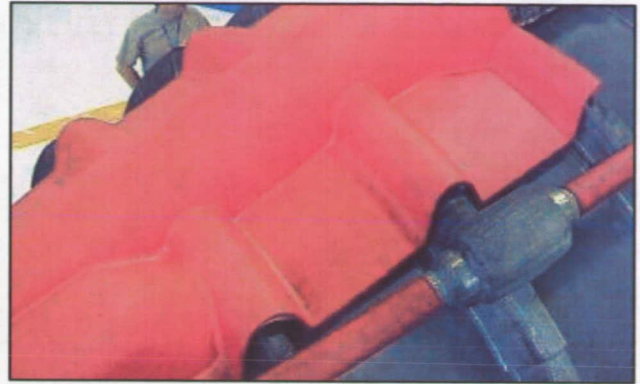
Figure 17- Protective covers being tried out

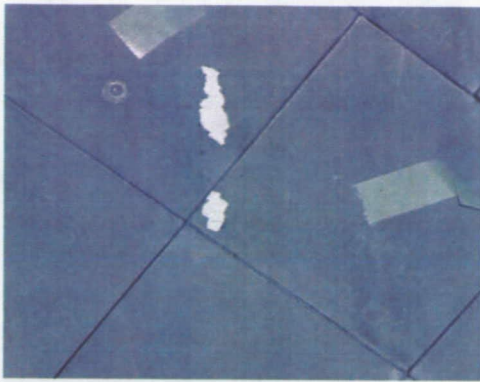
Figure 18– Post flight damage

After the Shuttle landing, surface damage was gathered with the scanner to verify in-orbit assessments and compare the data to post re-entry characteristics. This information was also used to investigate the source and the impactor. See *Figure 18 and 19.*

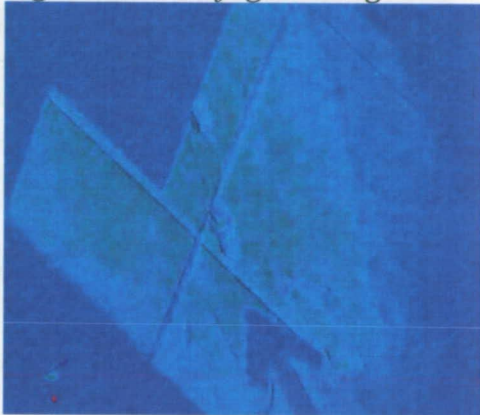
Figure 19 – Post flight damage scan

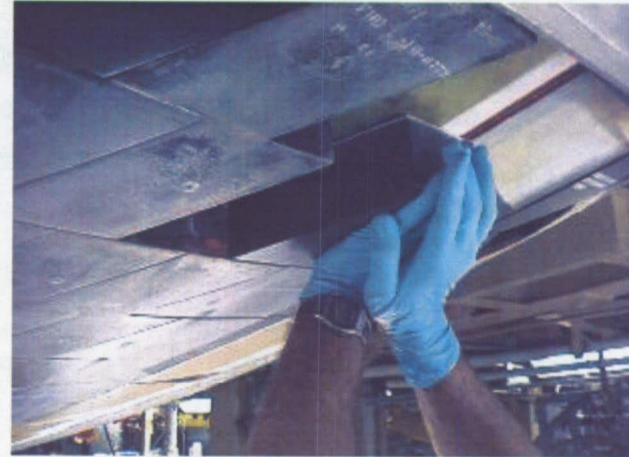
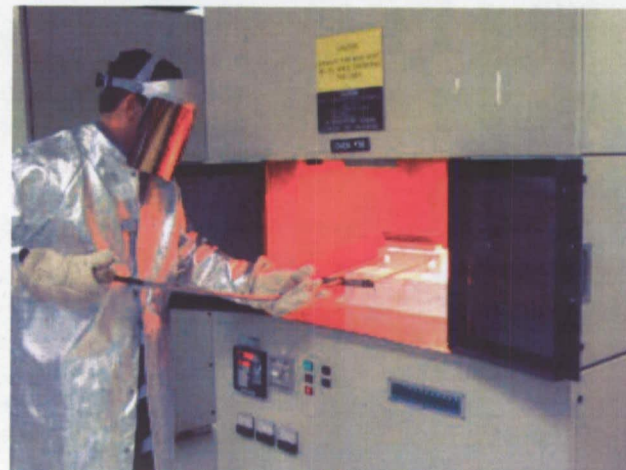
- Most tiles have a unique design
- Tolerance build up from surrounding tiles creates a unique cavity
- Tolerance build up is not reflected in our theoretical CAD data.
- Established processes involved a significant amount of iterations, before being able to cut a final tile

This resulted in a high cost per tile, and a long turn around time

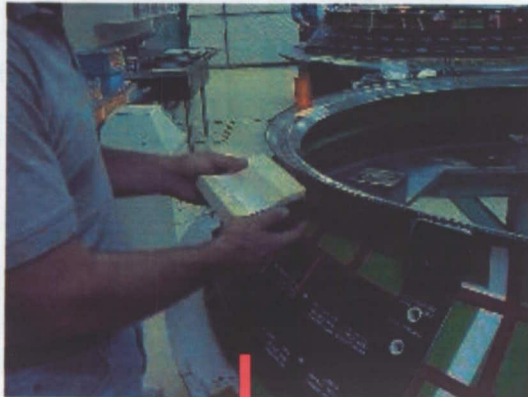
A foam pattern is made by hand.

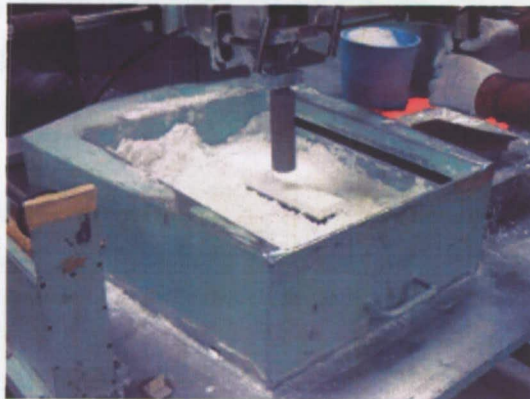
Pattern Is then traced with a gunstock machine

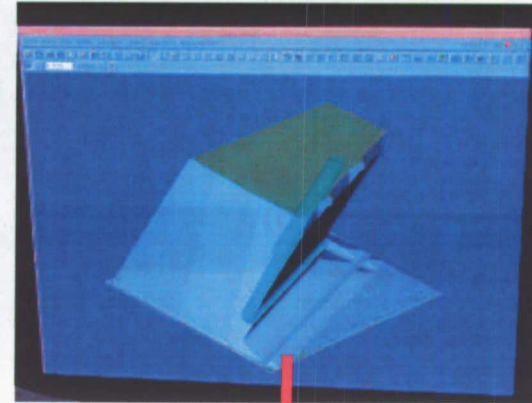
NC pattern cut from theoretical data.

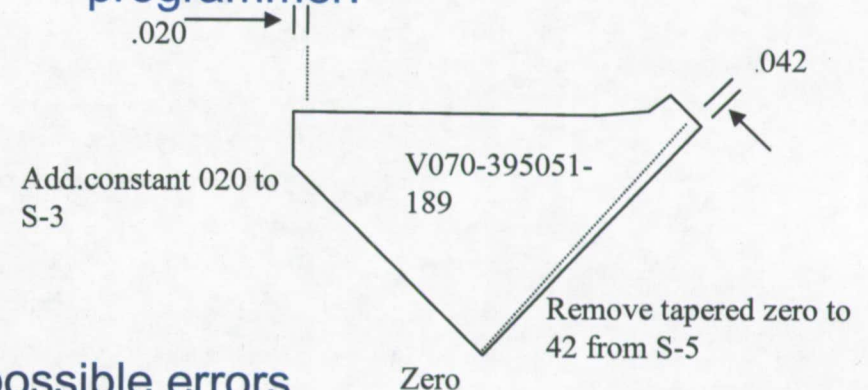
A sketch is then made with the required alterations for the programmer.

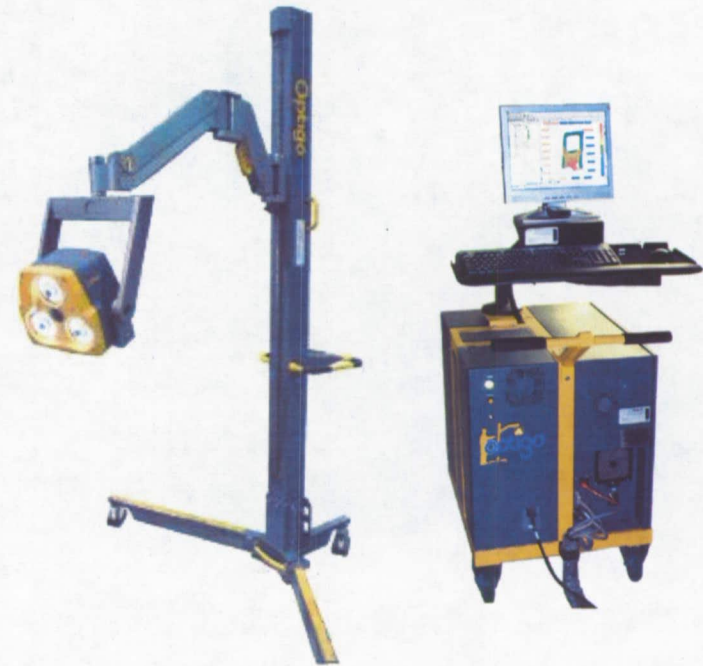
- USA select the Optigo 200 system, since it met the above challenges
- The system implements a unique white light technology

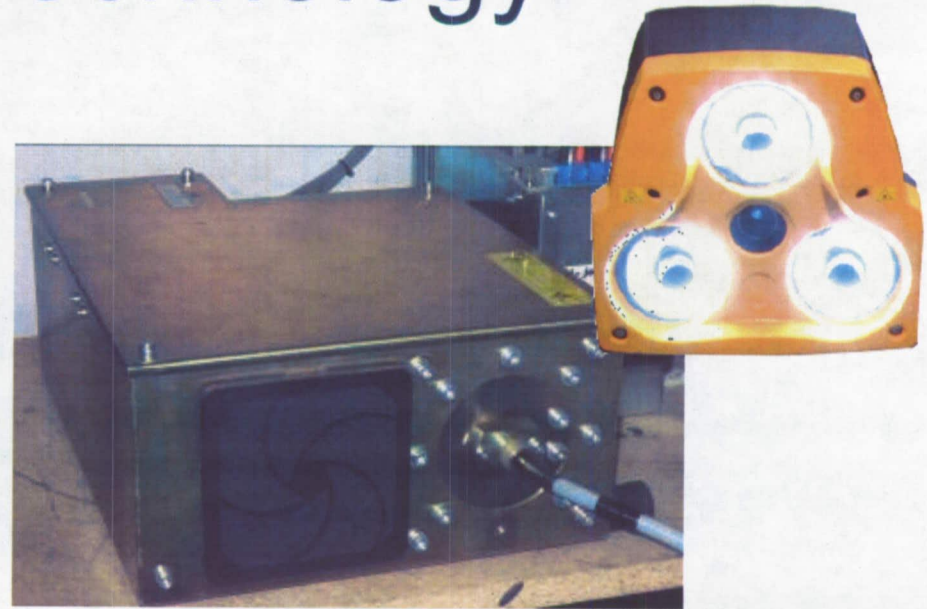
- **Reconstruction from one image projection**
- **Flash based light source**
- **Less than 1 millisecond exposure time**
- **This short time enables reconstruction of an area while it's moving relative to the optical head, and also allows for low sensitivity to external light sources**

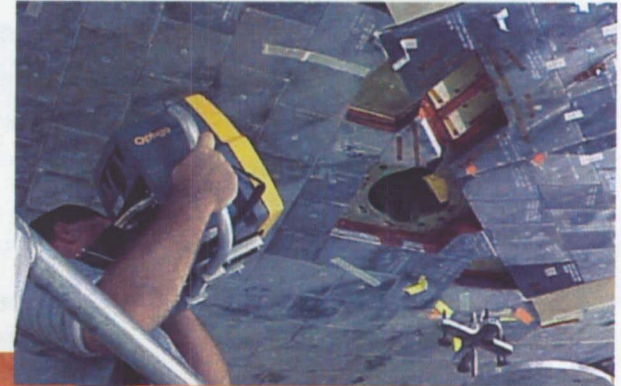
- Dual shutter cameras, enabling two sets of images acquired micro seconds apart
- The two images with two different light sources were acquired within less than 1 millisecond
- One shot captures retro reflective targets while the other captures the surface
- This enables motion of the optical head and the object during the image acquisition and thus handheld operation in a vibrating environment

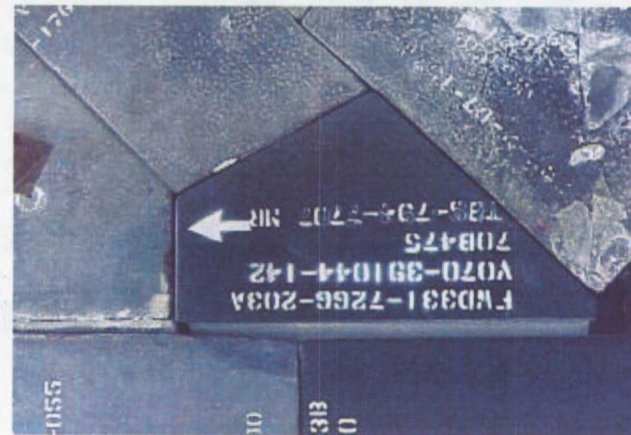
- The process involved scanning the cavity on the orbiter
- Reverse engineering the cavity to create tile design to fit the as built condition
- 5 axis mill cut the new tile
- Fit and assemble

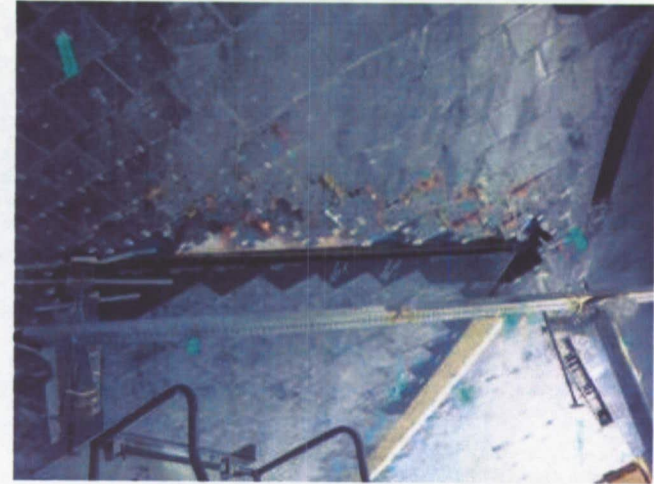
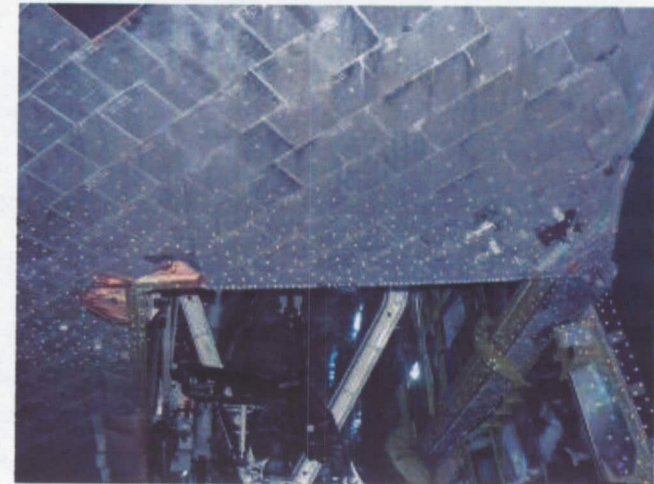
- Large sections had to be replaced to a higher strength material
- Mostly around openings
- Scan the door in an open position with tiles installed
- Tiles removed and a second scan is performed
- The door is then closed and a third scan is done

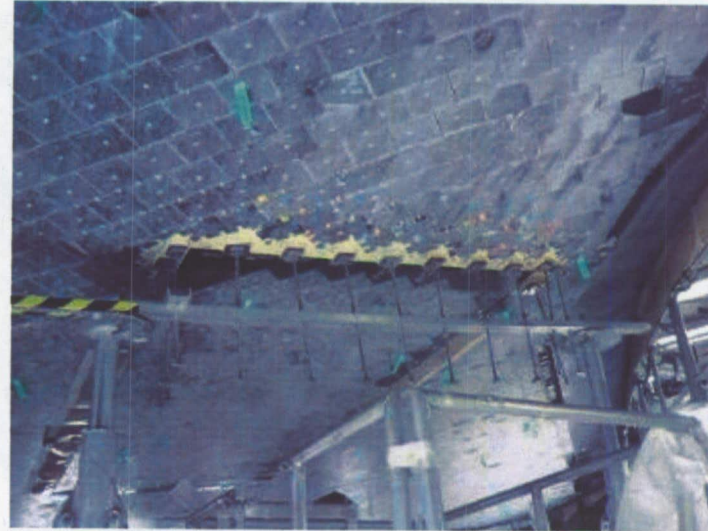
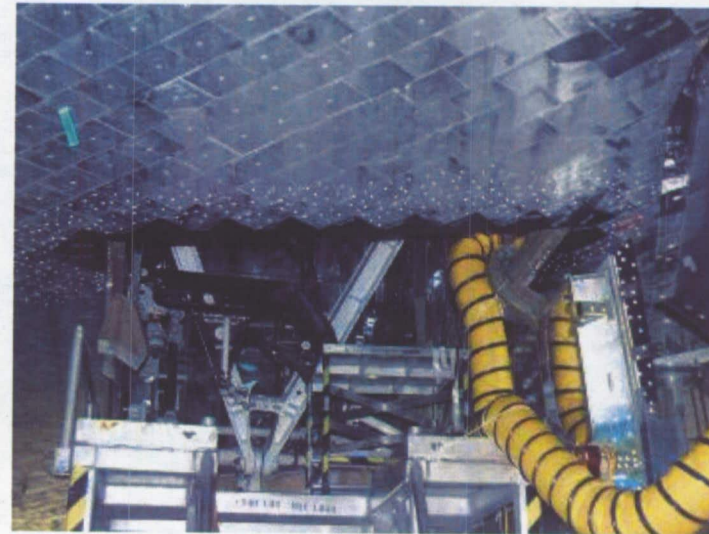
- Scans digitally assembled in closed position, resulting in exact cavity details
- Our old methods of hand fabrication or NC would require the doors to be closed for weeks!
- Time of doors closed was minimized, major enhancement for the rest of the systems workflow

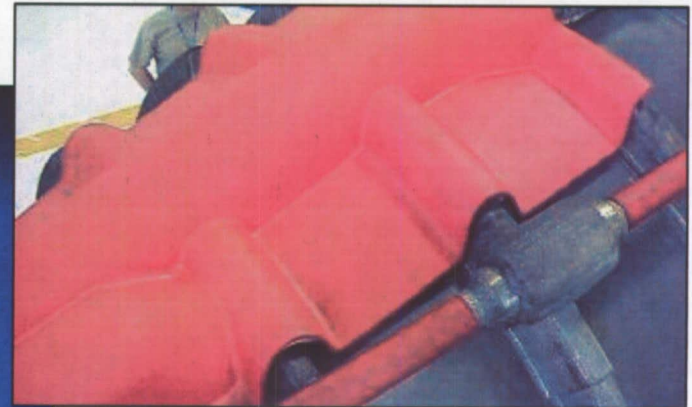
- Scanned post flight debris damage
- Date used for comparison between on-Orbit and post reentry differences
- Cavity characterized to determine the potential impactor

Another use of the scanner is for post flight debris damage assessment. During the first few days of a mission, Shuttle areas sustaining damage are scanned, and then analyzed to see if a fix is required.
